Environment Agency, Southern Region

## **River Medina Improvement Works**

**Assessment of obstructions and fish passage issues**

**Final Report**

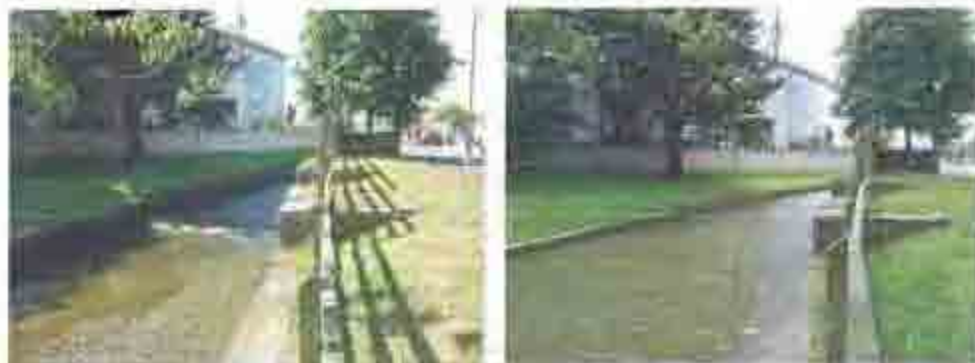
Figure 4.1. Structure 1 at low tide (July 24 2008) and near high tide (August 4 2008).

**Structure 1.** SZ 50166 89237. A low-head weir in the tidal channel (Figure 4.1). Its function would appear to be to provide bed stability. As it is drowned-out at high tide it represents no obstacle to fish movement, and it was not surveyed in detail.

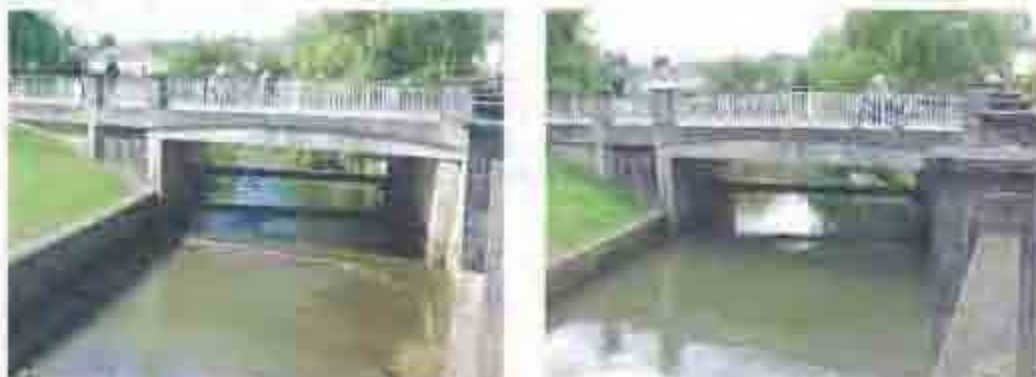
Figure 4.2. Structure 2 at low tide (July 24 2008) and near high tide (August 4 2008).

**Structure 2.** SZ 50237 89064. A low head weir with apron, beneath Pan Bridge (Figure 4.2). Function unknown; this may have been one of the "velocity control weirs" constructed as part of the second stage of the Flood Relief Scheme in the 1960's (Section 2.4). As it is drowned-out at high tide it represents no impediment to fish passage, and it was not surveyed in detail.

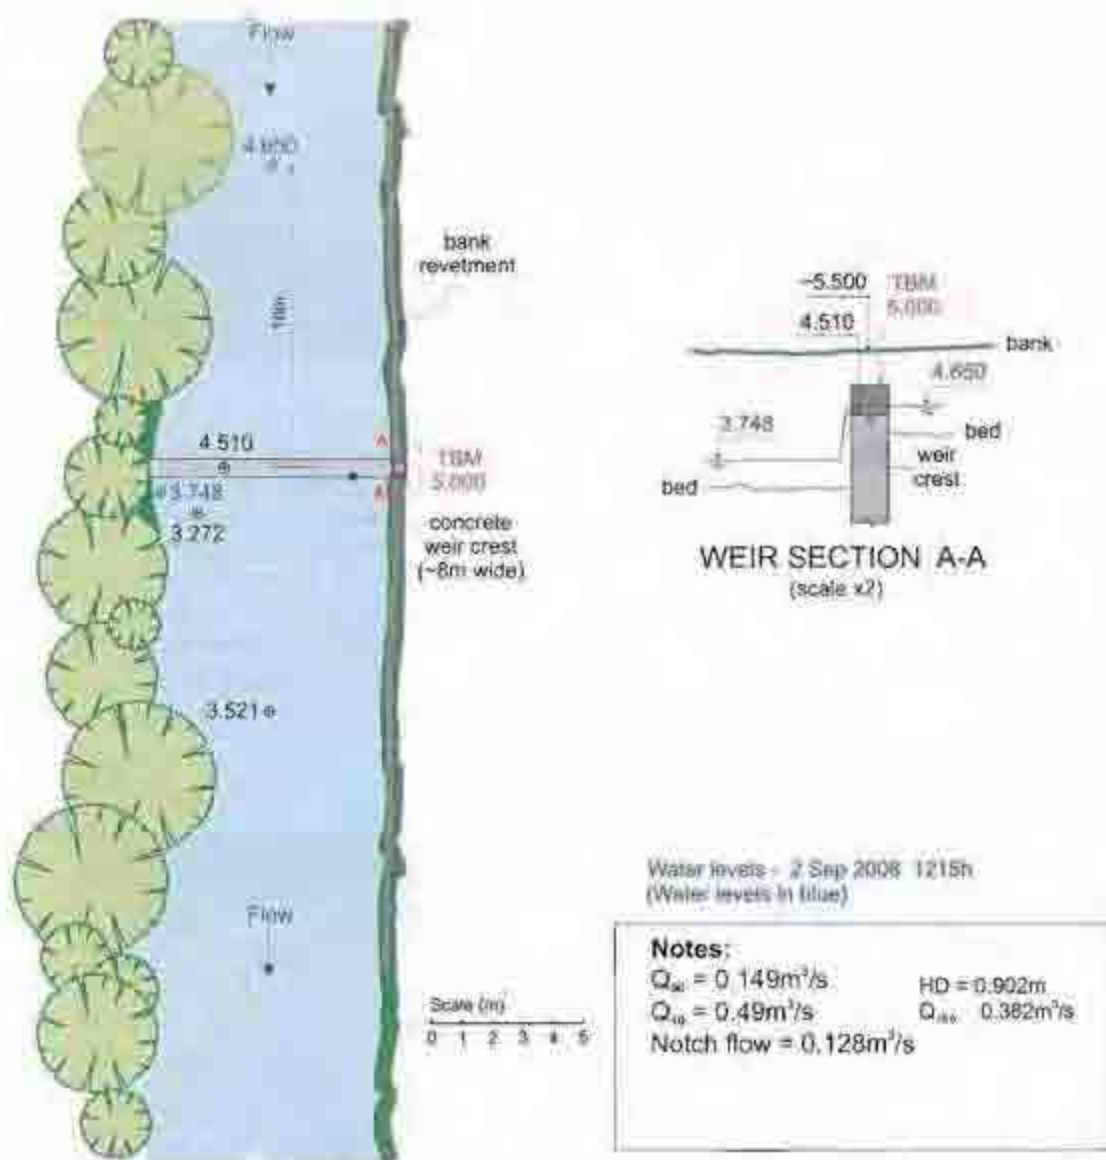
Figure 4.3 Plan of Matalan Lower Weir as surveyed.

**Structure 3.** Matalan Lower Weir, SZ 50233 88941. This is a weir with apron with a head loss of about 0.95 m (varying with the tide) in a single fall, set between vertical blockwork banks (Figures 4.3 and 4.4). It now represents the tidal limit, and has effectively replaced the head drop at Ford Mill. This is likely to have been one of the "velocity control weirs" constructed as part of the second stage of the flood relief Scheme in the 1960's. It would appear to be a significant impediment to upstream migration, at least at low tide levels.

In order to check to what extent tides reduced the head drop across this structure, recording depth-sensors were deployed upstream and downstream of the structure from September 3 to November 23 2008. Neap tides had no effect on the downstream level, and spring tides lifted the level by up to 0.4 m at peak. Even then this would leave a head drop of the order of 0.5 m. Thus while this weir could be passable by active swimmers such as sea trout under certain limited conditions, for most of the time it would be a serious impediment to migration. It is of little significance to freshwater fish as there is minimal freshwater habitat downstream.

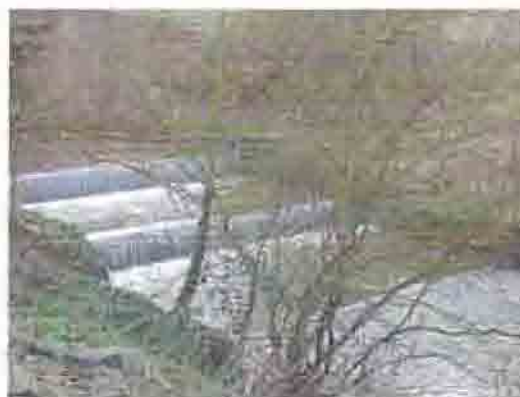
**Figures 4.4 and 4.5. Structures 3 (left) and 4 (right), February 6 2007.**

**Structure 4.** Matalan Upper Weir, SZ 50224 88793. This is a two-stage weir with a total head loss of 1.295 m (September 2 2008), and an apron to the lower stage, set between vertical blockwork banks (Figures 4.5, 4.8 and front cover). It is located about 120 m upstream of structure 3. This structure effectively replaces most of the head drop at Pan Mill, which is now bypassed, and almost certainly represents one or two of the “velocity control weirs” from the 1960’s flood relief scheme. It is a major impediment to upstream migration. It is of only minor significance to freshwater fish as there is only a short reach of freshwater river downstream of here, albeit good riverine habitat.

The second major obstruction is Matalan Upper Weir (Structure 4, Section 4.2). Two remedial options have been considered here. The first involves the installation of a Larinier fish pass (Armstrong *et al* 2004) within the right bank of the river (Figure 5.3). This would cost of the order of £90,000 and would provide good migration conditions for both trout and cyprinids. A much cheaper option would be to cut notches in the two existing weirs (Figure 5.3). This would not significantly reduce the head drops across each stage of the weir but would provide a much easier route of ascent for strong swimmers such as adult sea trout. It is unlikely to aid passage for cyprinids and eels, though as already discussed the former are hardly an issue this far down stream.

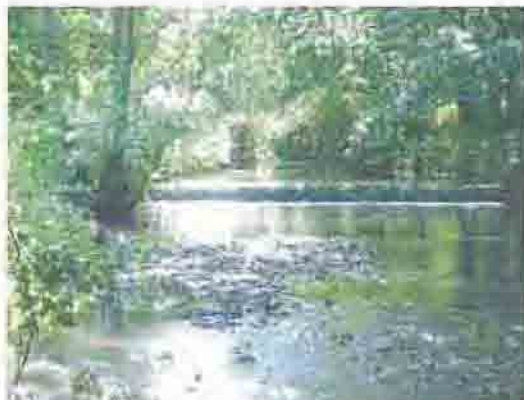
**Figures 4.6 and 4.7. Structures 5 (left) and 6 (right) in July 2008.**

**Structure 5.** Pan Mill Offtake weir, SZ 50341 88258. A concrete weir with apron with a head drop of the order of 0.45 m (Figure 4.6). This is one of the “velocity control weirs” that was constructed as part of the 1960’s flood relief scheme. It also provides the head for an offtake channel to Pan Mill. This channel was created during the construction of the flood relief scheme to maintain the water rights of the mill. The weir represents a significant impediment to movement at low flows due to the shallow water on the apron but may be less of an obstruction at high flows. This weir was surveyed and drawings could be produced without a further site visit.

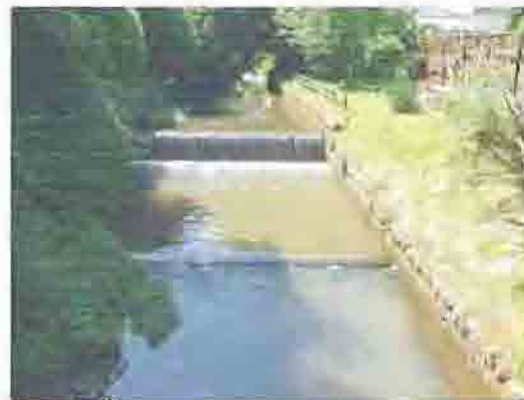
**Structure 6.** Lower Shide Footbridge weir, SZ 50341 88258. Another concrete weir with apron (Figures 4.7 and 4.9); the head drop was 0.7 m on September 2 2008.

is situated. The weir has a central notch and is unlikely to be a serious impediment to the migration of any species. This site was surveyed and detailed drawings could be produced without a further site visit.

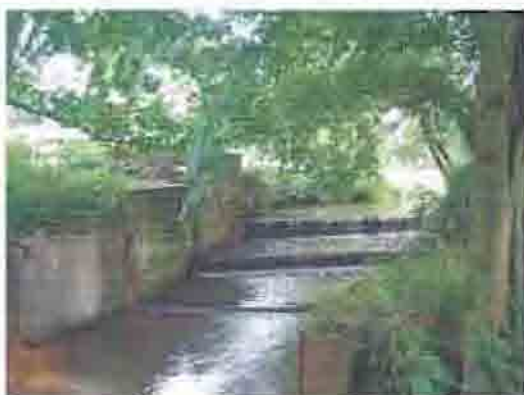
Figures 4.12 and 4.13. Structures 9 (left) and 11 (right) in July 2008.

The fifth major obstruction is the Upper Shide Mill Weir (Structure 9, Section 4.4), a three-stage construction with an overall head drop of about 1.1 m.

The proposal here is to notch all three weirs and provide a new fourth notched weir a short distance downstream (Figure 5.4). This would cost of the order of £35k. This would allow the free passage of sea trout but would not aid the passage of cyprinids and eels.

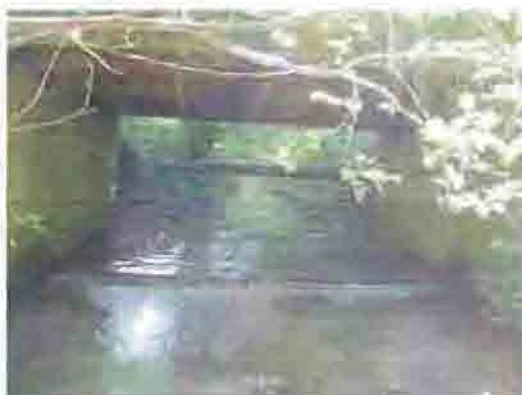
**Structure 11** SZ 50294 86915. A very low head (0.1 m) structure beneath a farm bridge (Figure 4.13). No impediment to fish movement.

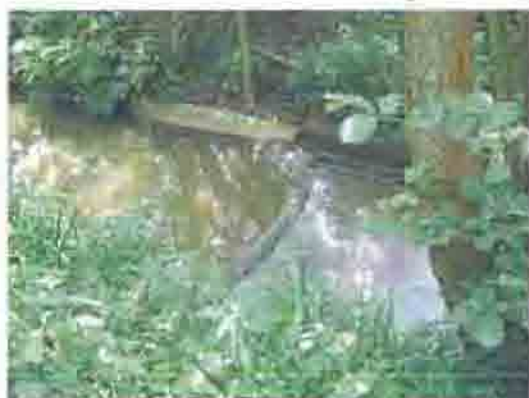
Figures 4.15 and 4.16. Structures 12 in July 2008 (left) and 13 (right) in September 2008.

**Structure 12** SZ 50558 86509. A low-head (0.2 m) board weir creating depth for an irrigation pump (Figure 4.15). Not a significant impediment to fish movement.

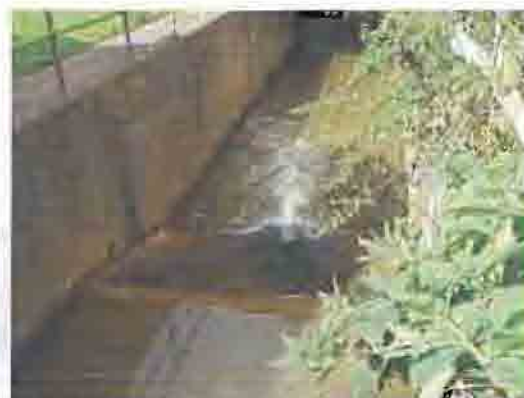
**Structure 13** SZ 50573 86463. A flat Vee flow gauging flume with a head loss of the order of 0.4-0.5 m (Figure 4.16). Likely to be an impediment to the movement of small fish.

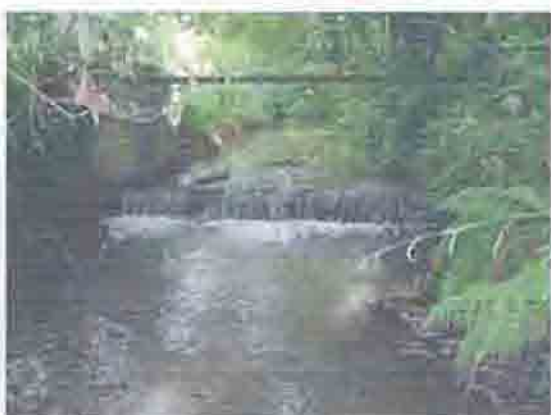
Figures 4.17 and 4.18. Structures 15 (left) and 16 (right) on July 24 2008.

**Structure 15** Blackwater Lower Weir, SZ 50448 86133. A wide-crested masonry weir with a head drop of the order of 0.4 m, with provision for oversail boards. (Figure 4.17). The function of this structure is unknown but the oversail board provision suggests that it once had a level management function, either to do with the mill or for amenity purposes. Likely to be an impediment to migration at low flows, requires assessing in higher flows.

The next significant obstruction is Blackwater Lower Weir (Structure 15, Section 4.5), which has a head drop of the order of 0.45 m and a long flat crest. No specific remedial action is presented here because of the alternative suggestion of bypassing both this and the next obstruction with a "new" channel. If this alternative proposal is not acted upon it is likely that a notch cut into the weir would allow passage of sea trout.

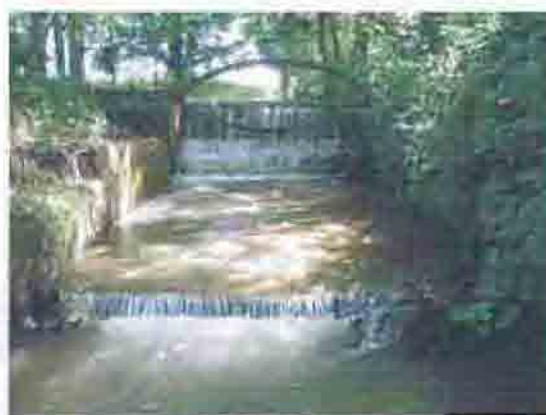
**Structure 16** Blackwater Upper Weir, SZ50552 86013. This large structure (Figures 4.18 and 4.23) effectively retains the head for Blackwater Mill, though it has been constructed since the mill ceased using water power.

It therefore currently has the function of maintaining the upstream level for feeding the mill pond, which is retained as a landscape feature in a large garden. The overall head loss from the retained upper level to the surface on the long shallow cill was 1.76 m on July 24 2008 and 1.86 on September 2 2008, of which about half was due to stop boards in slots above the concrete structure. It is a formidable obstruction for upstream passage of all species.

The seventh major obstruction is Blackwater Mill Weir (Structure 16, Section 4.5), which is the most formidable on the river with a head drop of the order of 1.86 m. Two specific solutions were considered here, that of a Larinier pass in the left bank, and a pool and traverse pass constructed within the existing channel (Figure 5.5).

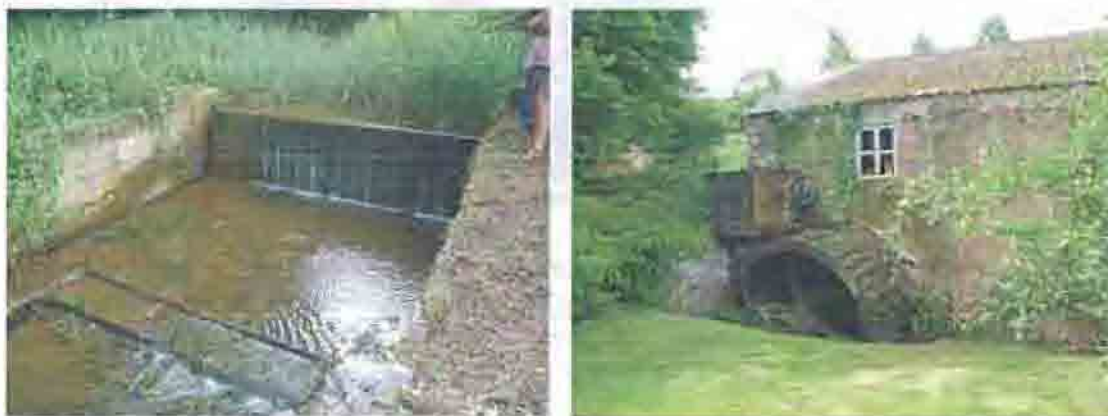
Figures 4.19 and 4.20. Gatcombe Mill pond dam and waterwheel, July 24 2008.

**Structure 17** Gatcombe Mill Weir, SZ 49912 85202. This concrete dam (Figure 4.19) was erected about 1954 to replace the Gatcombe Mill dam that had been destroyed in a flood in 1951. Its crest is about four feet lower than the original, isolating the mill wheel from its water supply (Figure 4.20). It is a major impediment to upstream migration.

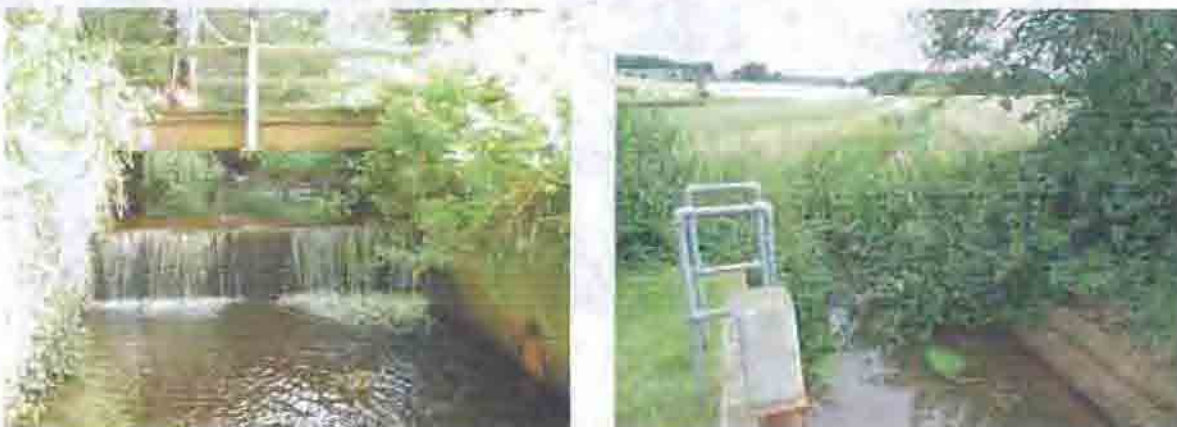
Figures 4.21 and 4.22. Left; structure 18. Right: structure 20, looking upstream.

**Structure 18** SZ 49818 84986. A weir with a head of about 0.4 m, on the branch of the river feeding the mill pond (Figure 4.21). Not surveyed in detail.

**Structure 20** Highwood Lane Gauge, SZ 49761 84601. Said by Environment Agency to be a weir with gauge, but inspection failed to reveal any significant head-drop structure (Figure 4.22). In any event there appeared to be little habitat upstream of here suitable for anything but smaller species and eels, so regarding this as the upper limit of the project area appears appropriate.

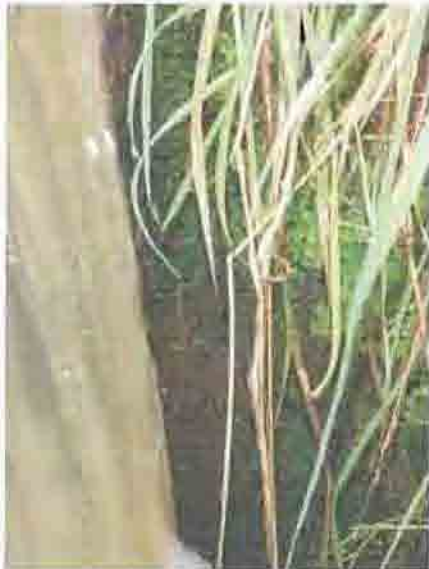
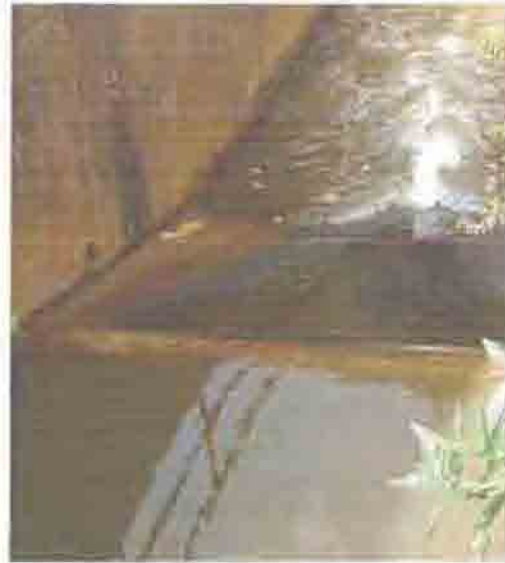
Figure 4.24 (left). Growth of wet moss and liverworts at the side of Structure 3 which probably allows ascent by elvers. Figure 25 (right). Moss growing in the very shallow edge of Structure 13 which is likely to allow ascent of small eels.
