Hampshire and Isle of Wight Wildlife Trust : Wroxall Stream Project

Catchment Partnership Action Fund

Fen restoration and tree management

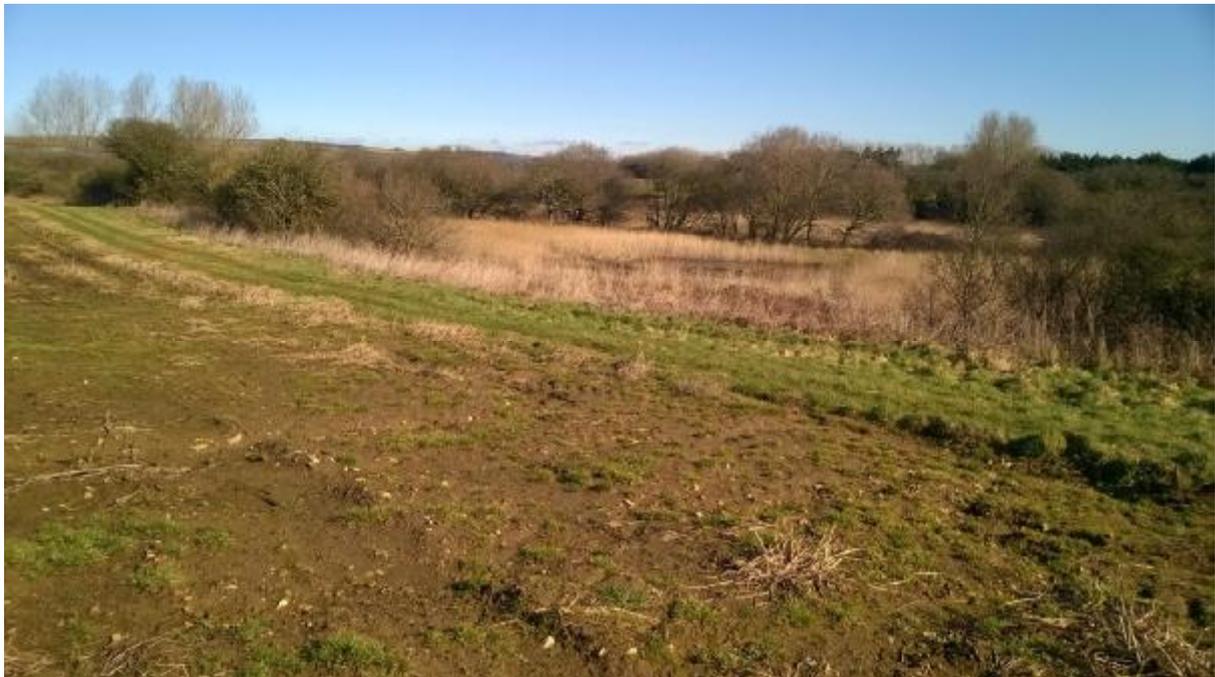
Figure 1 : Maize field adjacent to Wroxall Stream floodplain

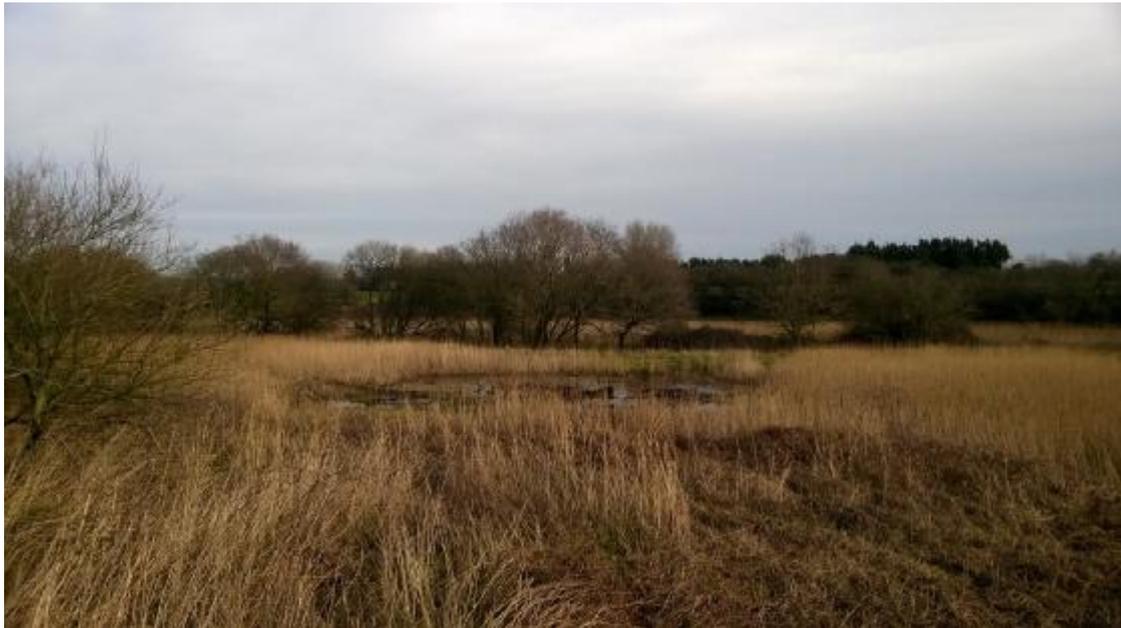
Figure 2 : reed bed with scrub removed

- reed beds occur in the floodplain so that a natural biobed is already in place but is being invaded by scrub – mainly grey willow (*Salix cinerea*)
- riparian tree growth is causing deep shade and preventing the establishment of buffer vegetation and increasing the likelihood of bank-side erosion

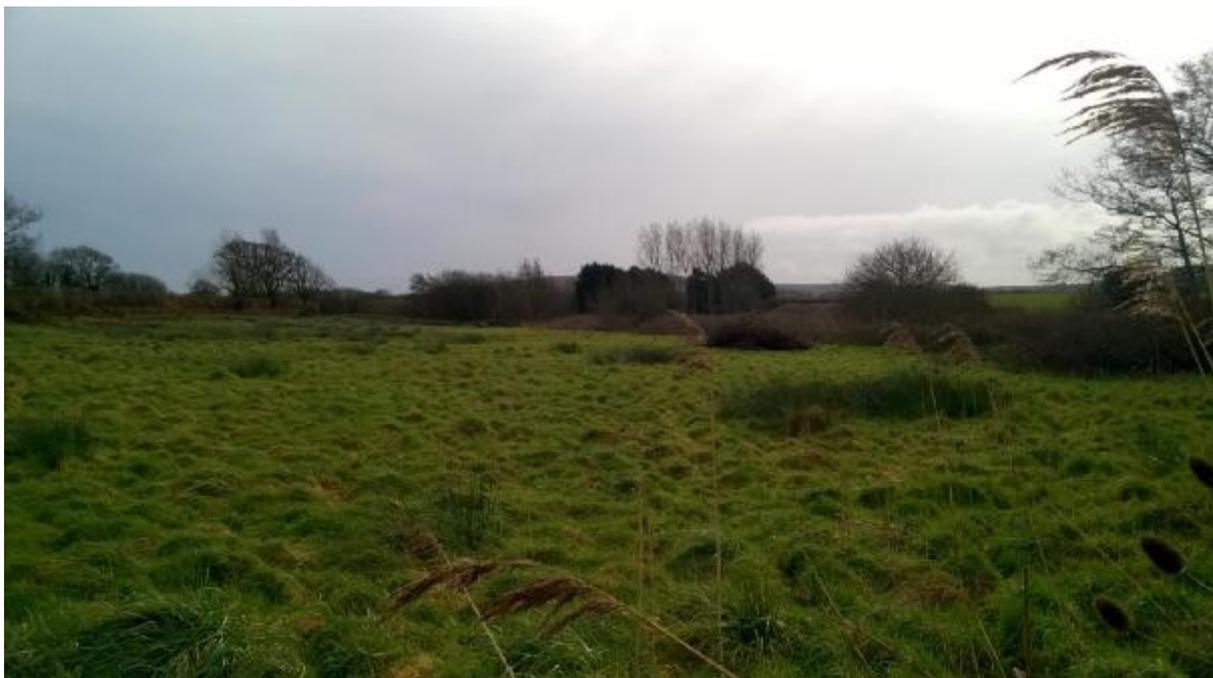
Figure 3 : Wroxall Stream prior to works

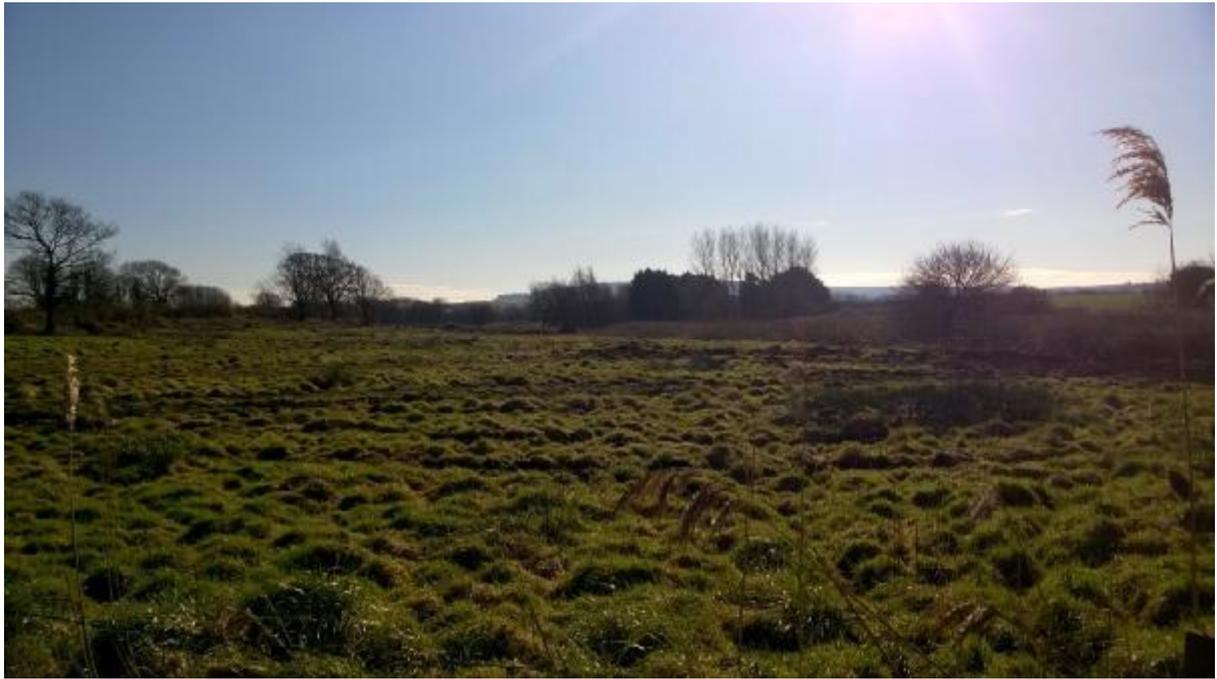
Figure 4 : Wroxall post works

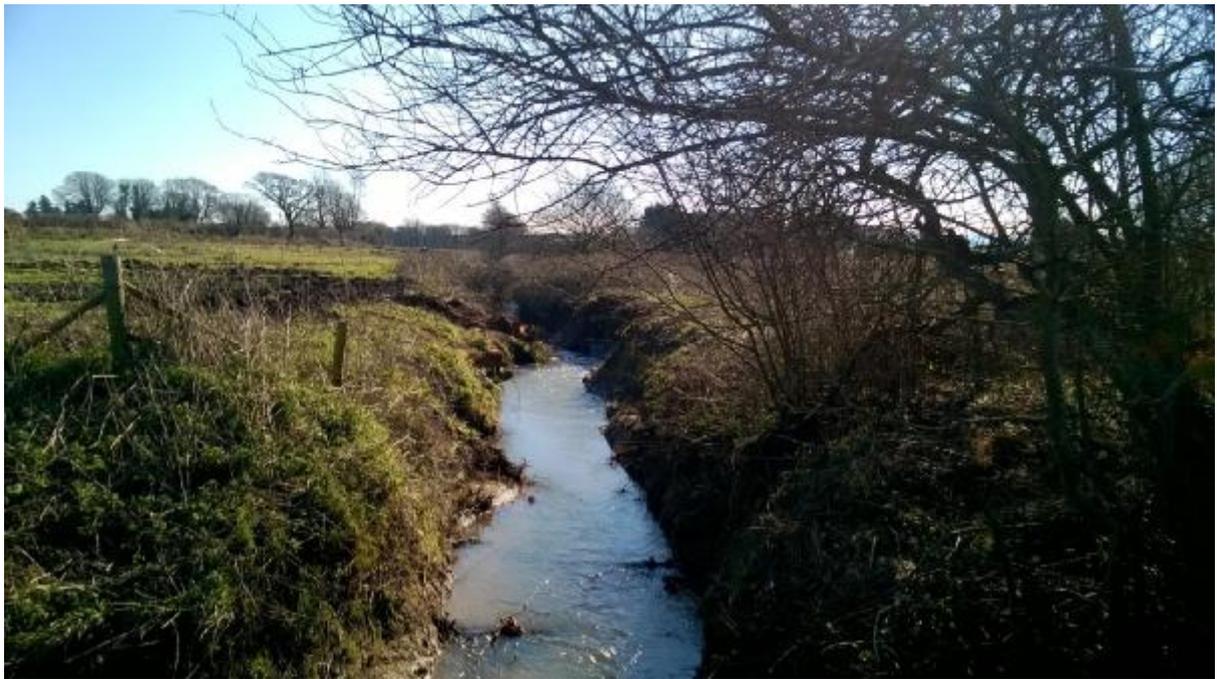
Figure 5 : Wroxall with tree removed

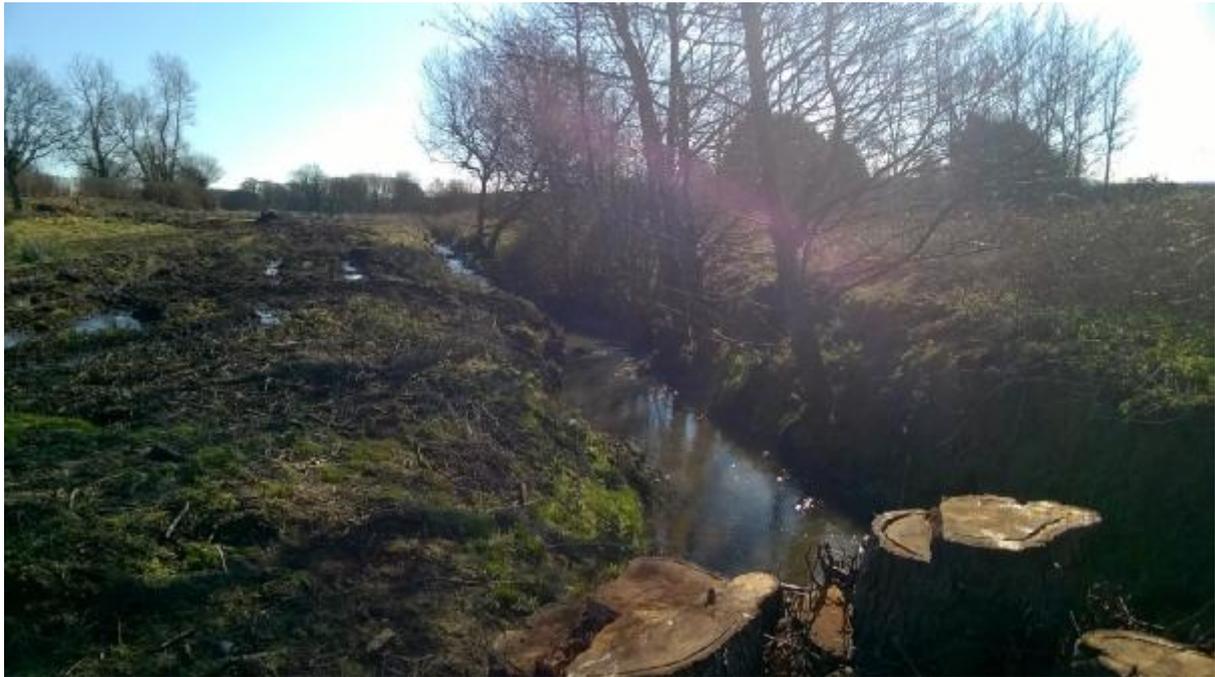
Figure 6 : Wroxall stream – post works

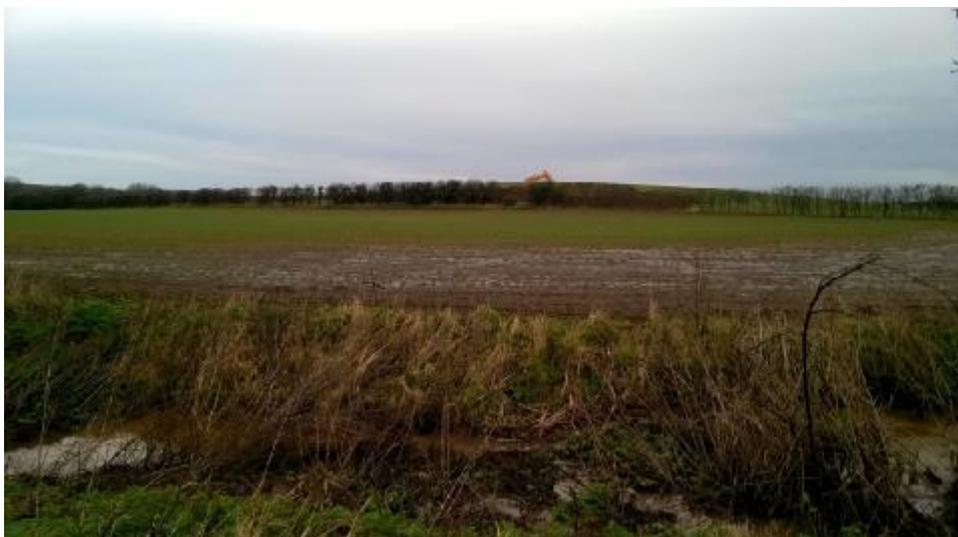
Figure 7 : Maize field with erosion and no buffer

It has been proposed that work on the Wroxall is enhanced by the construction of a low bund along the watercourse at Bathingbourne. This bund will act to trap sediment which is a major source of phosphate from the maize fields surrounding it.

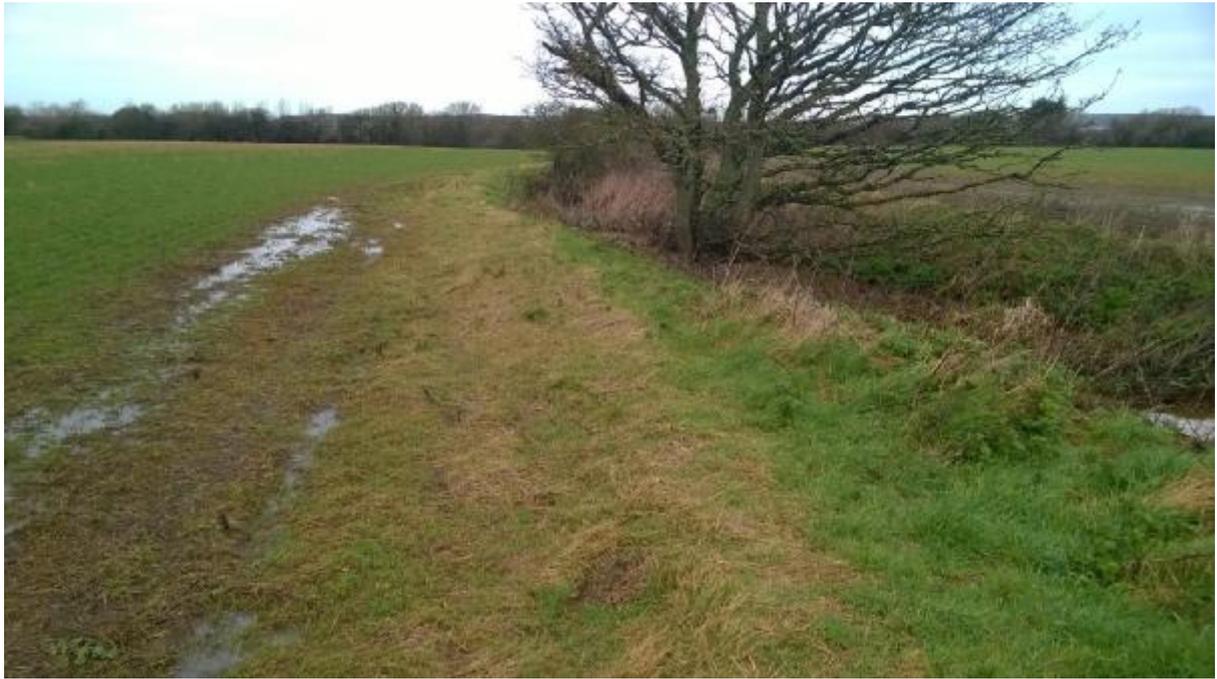
Figure 8 : Maize field with streamside bund

The presence of these bunds has worked on other parts of the farm but have been constructed by the piling of arisings from the stream following decades of clearance and deepening rather than through active pollution control and management.
