Environment Agency, Southern Region

## **River Medina Improvement Works**

**Assessment of obstructions and fish passage issues**

**Final Report**

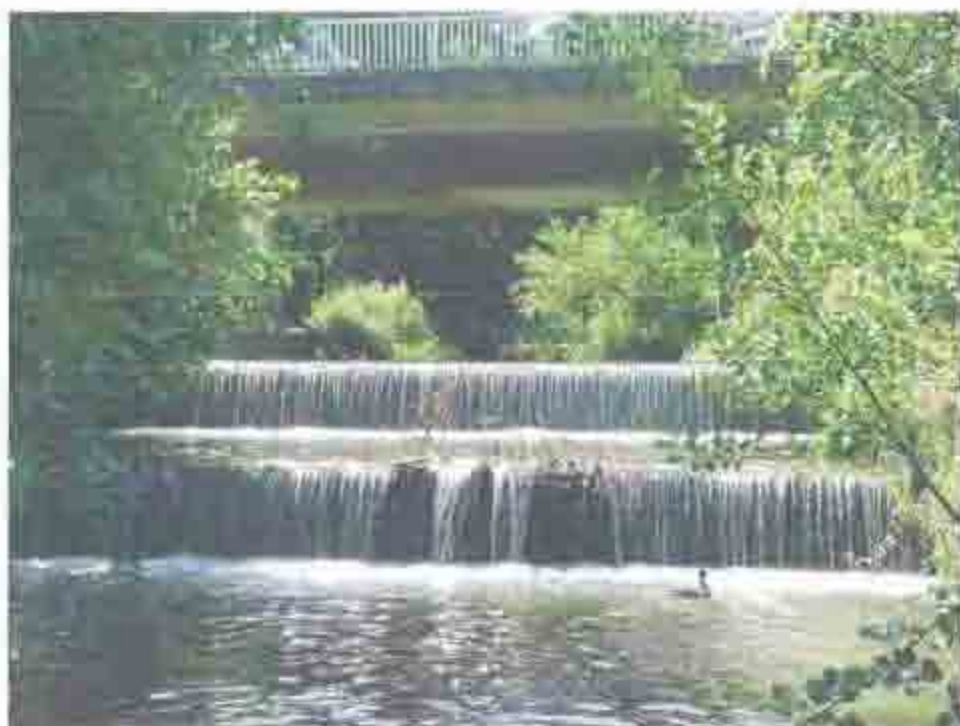
*Front cover picture - a "velocity control weir" constructed for flood defence purposes in the 1960's, just above the tidal limit in Newport. Overall head drop 1.4 m.*

**Structure 4.** Matalan Upper Weir, SZ 50224 88793. This is a two-stage weir with a total head loss of 1.295 m (September 2 2008), and an apron to the lower stage, set between vertical blockwork banks (Figures 4.5, 4.8 and front cover). It is located about 120 m upstream of structure 3. This structure effectively replaces most of the head drop at Pan Mill, which is now bypassed, and almost certainly represents one or two of the “velocity control weirs” from the 1960’s flood relief scheme. It is a major impediment to upstream migration. It is of only minor significance to freshwater fish as there is only a short reach of freshwater river downstream of here, albeit good riverine habitat.

The second major obstruction is Matalan Upper Weir (Structure 4, Section 4.2). Two remedial options have been considered here. The first involves the installation of a Larinier fish pass (Armstrong *et al* 2004) within the right bank of the river (Figure 5.3). This would cost of the order of £90,000 and would provide good migration conditions for both trout and cyprinids. A much cheaper option would be to cut notches in the two existing weirs (Figure 5.3). This would not significantly reduce the head drops across each stage of the weir but would provide a much easier route of ascent for strong swimmers such as adult sea trout. It is unlikely to aid passage for cyprinids and eels, though as already discussed the former are hardly an issue this far down stream.

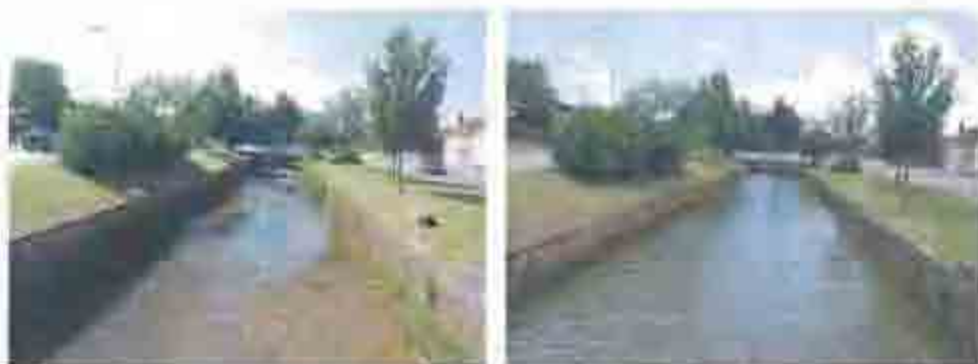
Figures 2.1. and 2.2. Looking upstream to the site of Ford Mill, Newport, at low tide on July 24 2008 (left), and near high tide on August 4 2008 (right). The mill was situated where the bridge in the distance is located, and it formed the tidal limit. The tide now penetrates a few hundred metres further to a large weir.

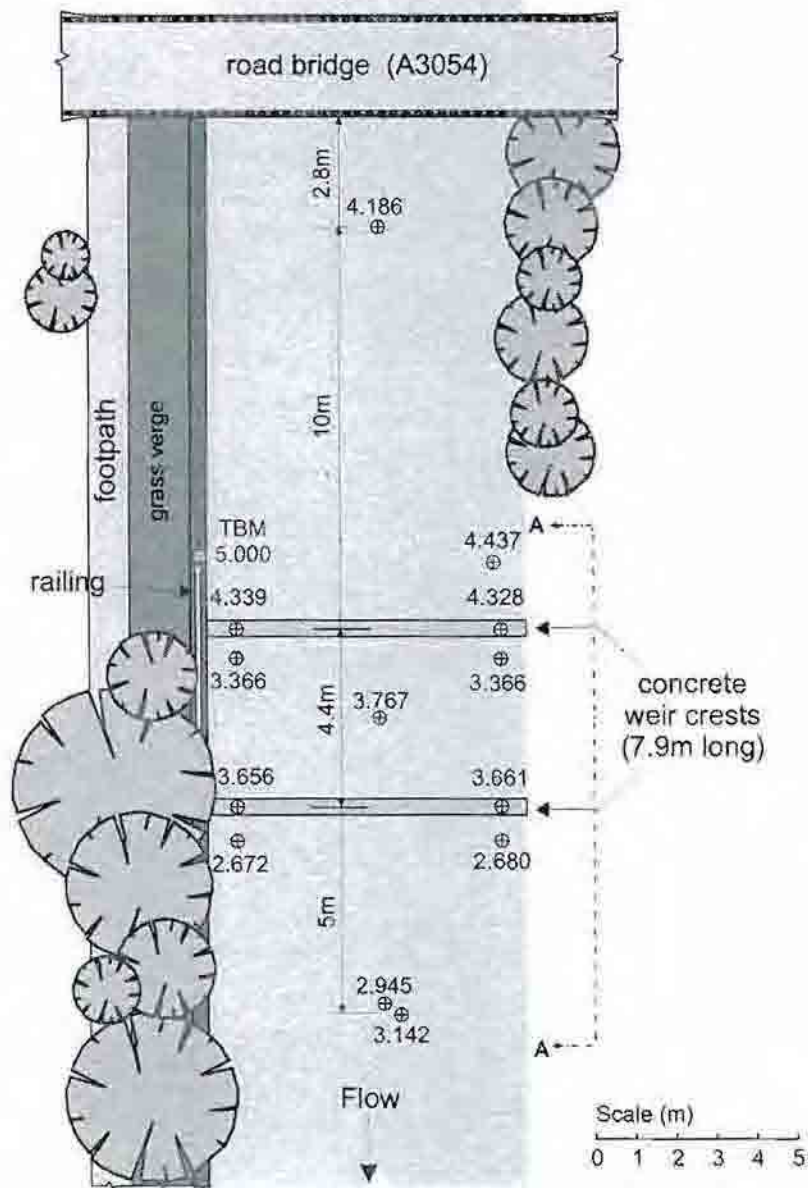
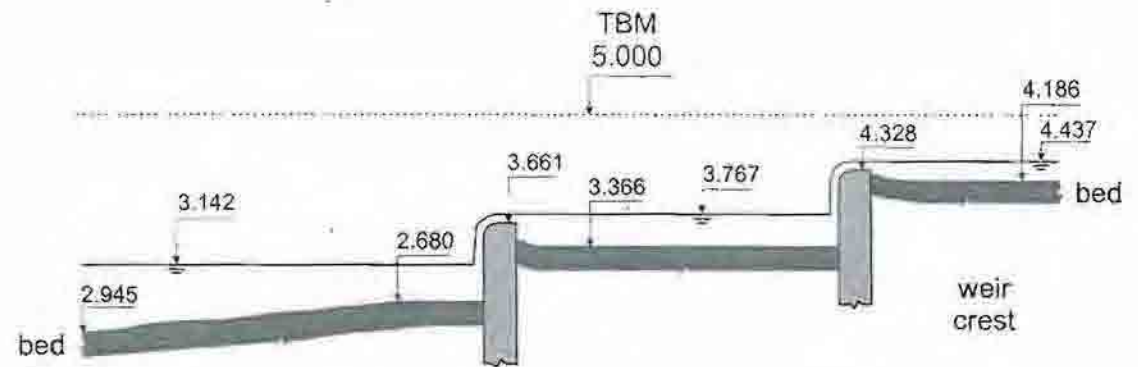
(4A) MATALAN UPPER WEIR

Figure 4.8. Plan of Matalan Upper Weir, as surveyed

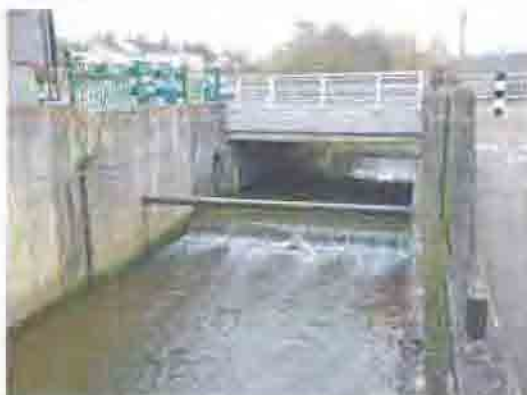
Figures 4.10 and 4.11. Structures 7 (left, February 2007) and 8 (right, July 2008). The design of the works shown in Figure 4.10 was said to have "paid particular regard to amenity"!

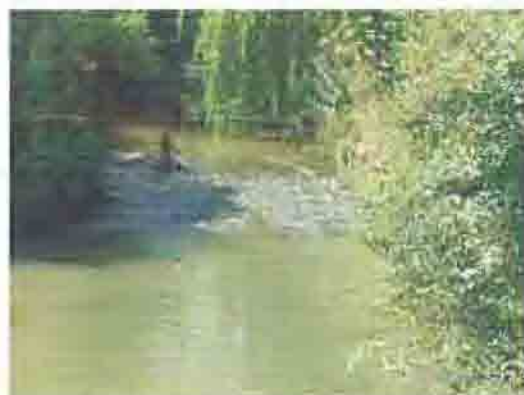
**Structure 8** Shide Ramp Weir, SZ 50360 88092. A low, gently sloping stone weir with a head loss of the order of 0.3 m, and provision for stop boards to increase the head (Figure 4.11). The original function is unclear but it is an attractive feature and probably not a serious impediment to migration at higher flows; at times of low flow (as when the photograph in Figure 4.8 was taken) there is just a few centimetres of water over the face of the weir.

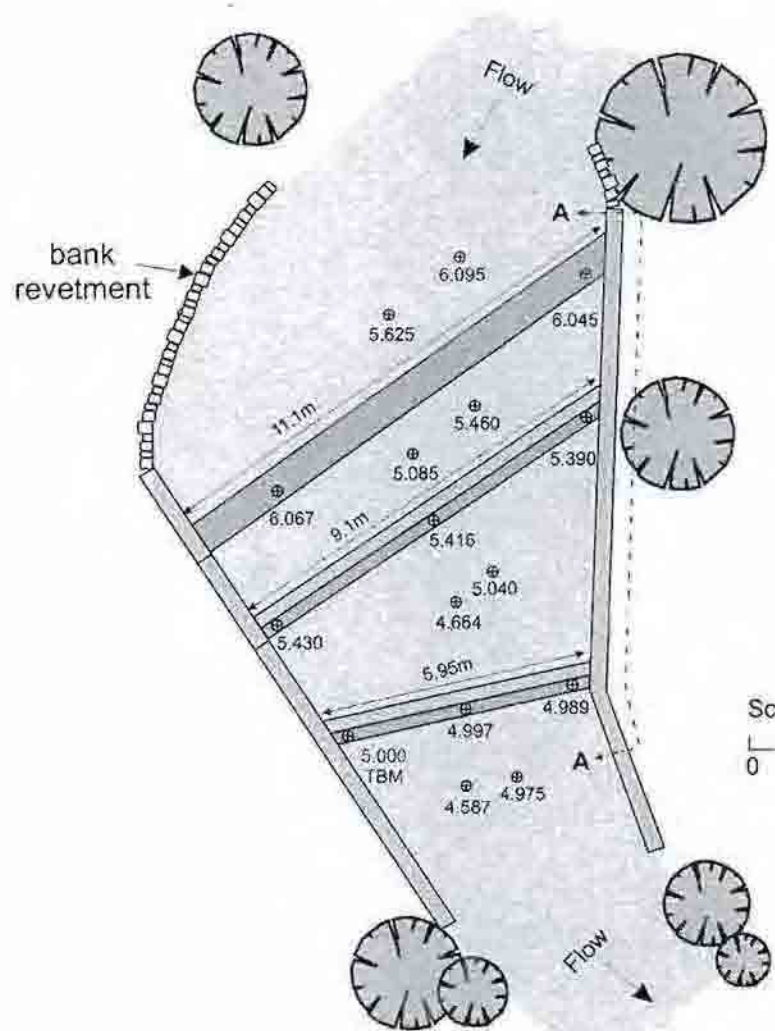
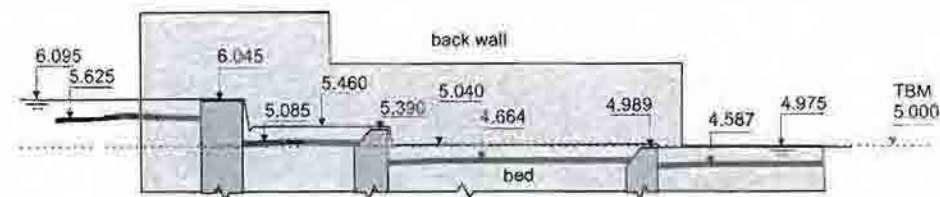
SECTION - VIEW ON A-A

**Structure 9** Upper Shide Mill Weir, SZ 50254 87661. This is a three-stage concrete weir set at an oblique angle to the stream, and with a total head loss of about 1.1 m (Figures 4.12 and 4.14). Clearly a "velocity control weir" from the flood relief scheme it effectively retains the head that was maintained by Shide Upper Mill. This is likely to be a major impediment to fish movement.

The proposal here is to notch all three weirs and provide a new fourth notched weir a short distance downstream (Figure 5.4). This would cost of the order of £35k. This would allow the free passage of sea trout but would not aid the passage of cyprinids and eels.

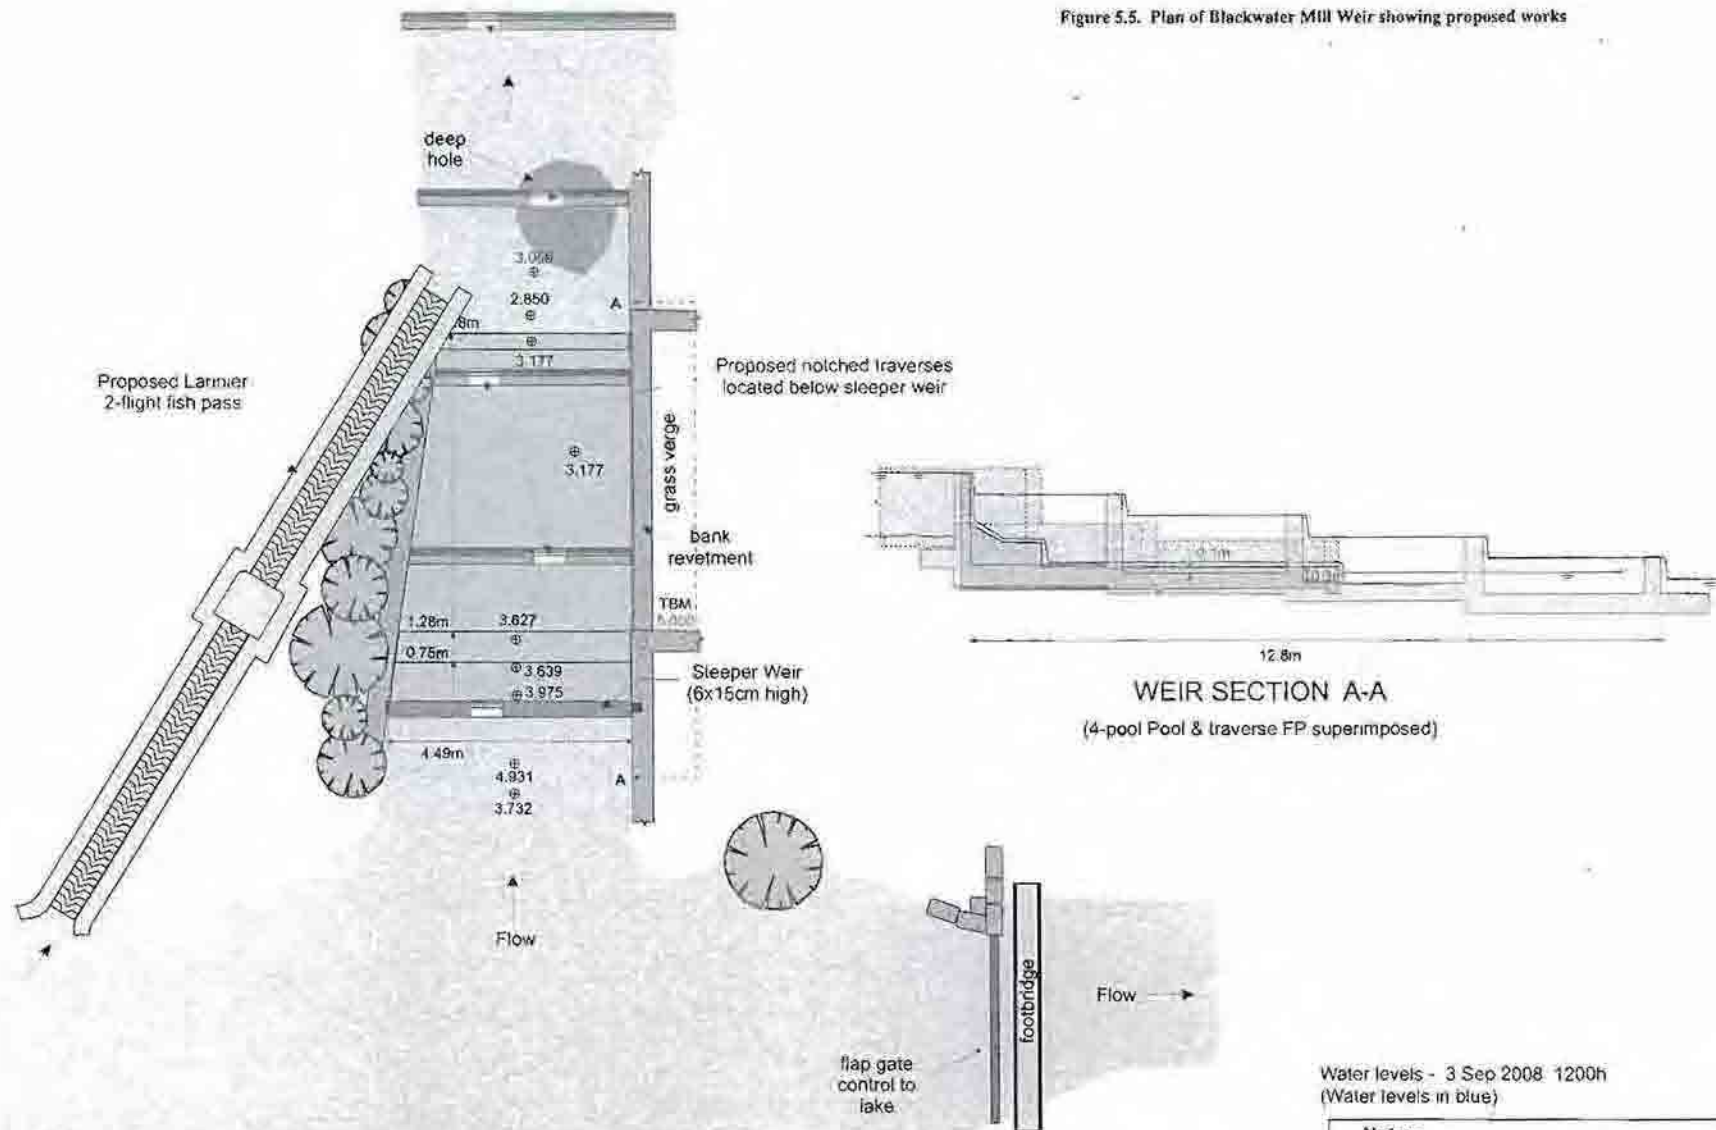
(16B) BLACKWATER MILL WEIR  
(Layout Diagram)

The seventh major obstruction is Blackwater Mill Weir (Structure 16, Section 4.5), which is the most formidable on the river with a head drop of the order of 1.86 m. Two specific solutions were considered here, that of a Larinier pass in the left bank, and a pool and traverse pass constructed within the existing channel (Figure 5.5).

Figure 5.5. Plan of Blackwater Mill Weir showing proposed works
